ELGESETER BRIDGE IN TRONDHEIM DAMAGED BY ALKALI SILICA REACTION: MICROSCOPY, EXPANSION AND RELATIVE HUMIDITY MEASUREMENTS, TREATMENT WITH MONO SILANES AND REPAIR

Viggo Jensen, *Norwegian Concrete and Aggregate Laboratory Ltd, 7018 Trondheim, Norway*; viggo.jensen@nbt.no

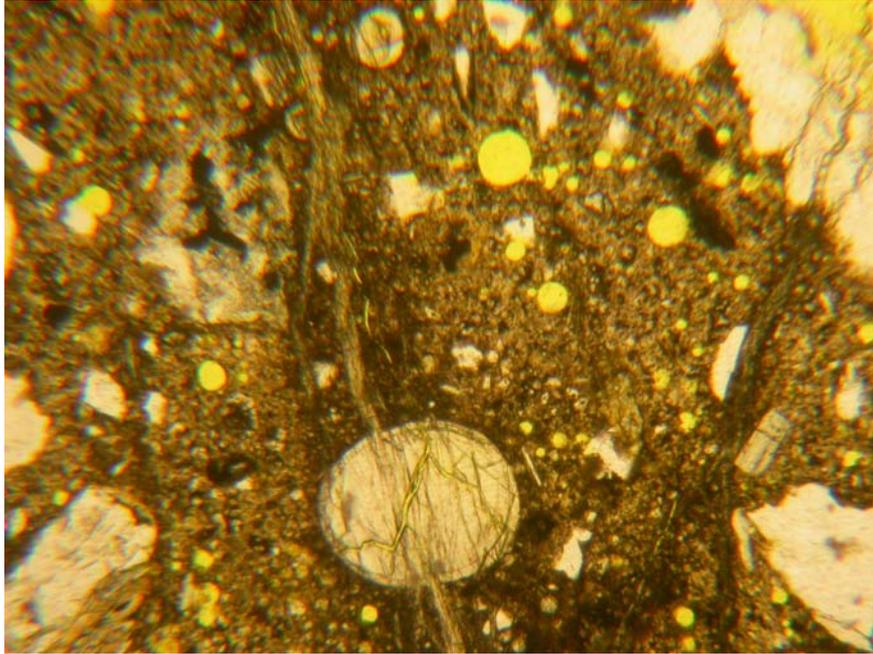
White gel precipitations in air voids and cracks, dark rims around coarse aggregates and cracked aggregates were observed in all the cores, observations which suggest occurrence of ASR. The laboratory investigation revealed that deleterious ASR occurred in all the cores. Therefore, it is most likely that ASR causes the observed cracking and expansions. Figure 6 shows reaction products in an air void and cracks in the cement paste (thin sections).

Figure 6: gel precipitation in an air void and cracks and occurrence of many small air voids (yellow) in the cement paste. Plane polarized light. Length of photo is 2 mm.

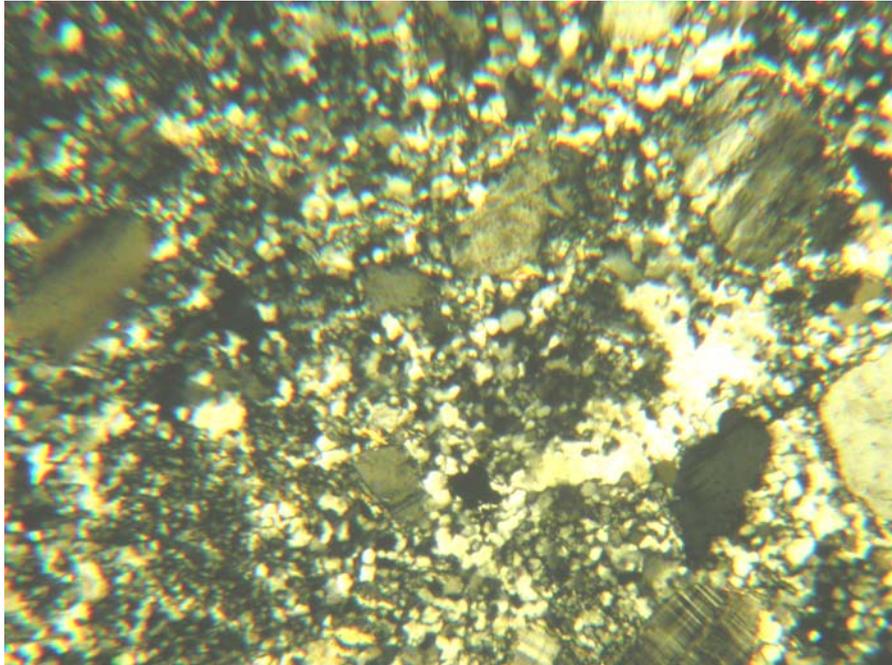
Figure 7 shows micro texture of mylonite where the precursor rock is probably sandstone. Only feldspar has survived the process of cataclasis.

Figure 7: micro texture of mylonite photographed in polarizing light. Length of photo is 2 mm.

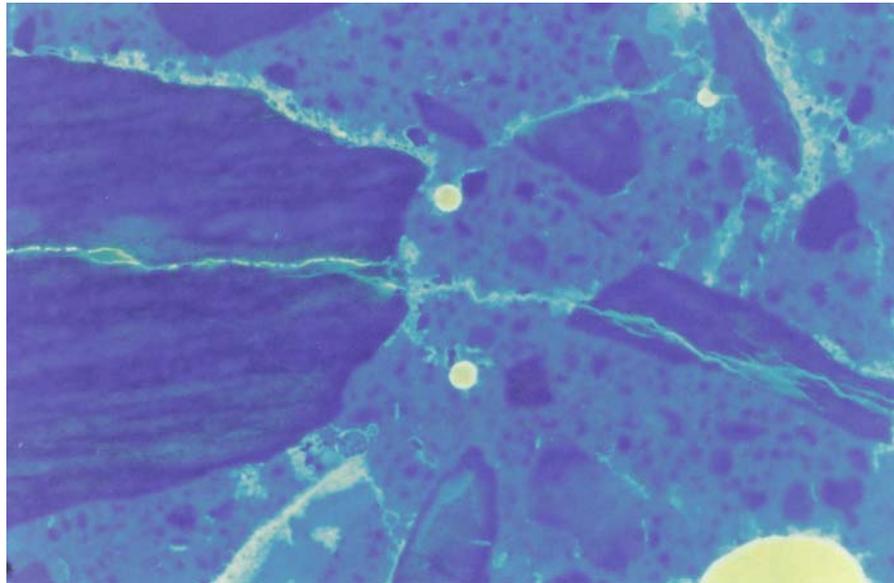
Table 3 includes results from a classification system by Jensen [3], namely “% cracked aggregates” and “cracks in paste”. The results are obtained by counting aggregates containing cracks and aggregates where cracks runs into the cement paste (significant for ASR) as well as number of cracks in the cement paste. This on fluorescent impregnated polished half cores sawed along the length axe and observed in UV-light.

Figure 8: fluorescence impregnated concrete in UV light. Cracks occur in aggregates and in the paste

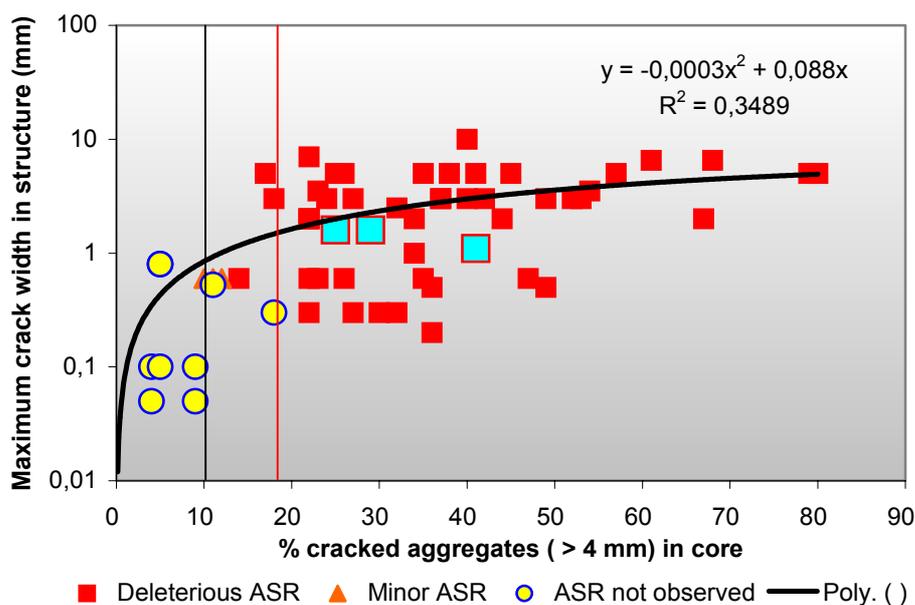
Figure 9 shows % cracked aggregates in cores related to maximum crack width in structure [3]. The plot is based on 83 cores from structures in Southern Norway. The cores were ranked as “deleterious ASR”, 52 cores, “minor reaction”, 7 cores, and “ASR not observed”, 24 cores. ASR was documented by examination of 112 thin sections. Elgeseter bridge is shown with blue squares in figure 9.

Figure 9: % cracked aggregates in cores related to maximum crack width in the structure. Results from Elgeseter bridge are shown as blue squares.

Figure 9 is a plot of cracks in structures and cracks in cores. Because of the uncertainties (counting in cores and measurements of maximum crack width in structure) the correlation is rather low but real. Moreover, a “gray zone area” between 10% and 18 % cracked aggregates (see figure 9) exists where “deleterious ASR”, minor ASR and “ASR not observed” plot together. From this investigation it can be suggested that less than 10% “cracked” aggregates is the limit to distinguish between concretes suffering from ASR or not.

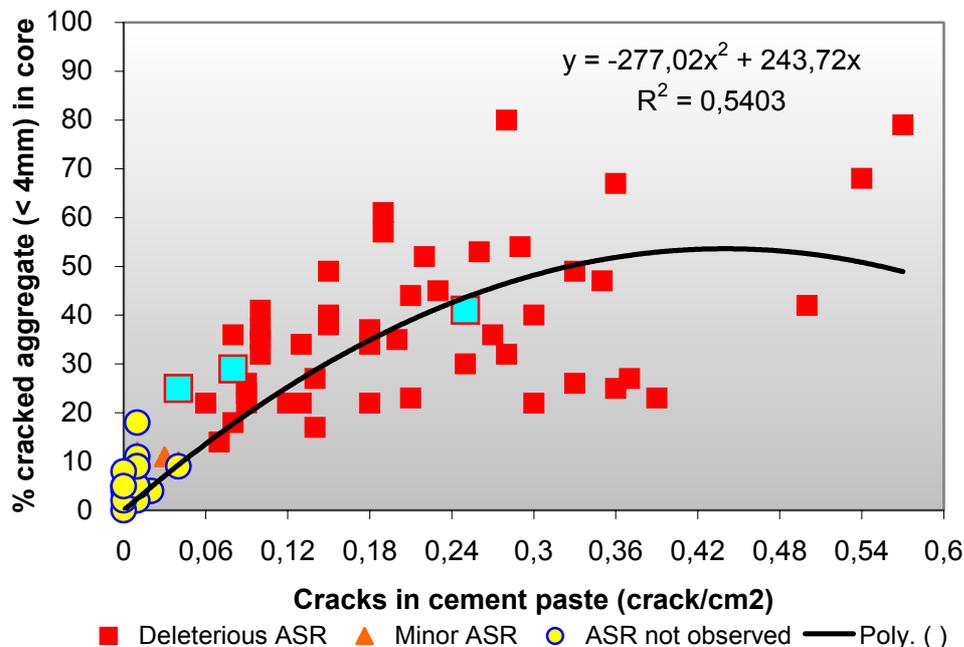
Figure 10: % cracked aggregates and cracks in cement paste in cores. Results from Elgeseter bridge are shown as blue squares.

Figure 10 shows % cracked aggregates and cracks in cement paste from the same 83 cores. Results from Elgeseter bridge are marked with blue squares. The figure shows an acceptable correlation between “% cracked aggregates” and “cracks in paste”. Therefore, it is likely that ASR has caused most of the cracks occurring in the paste. Very few cracks occur in samples where ASR not has been diagnosed.

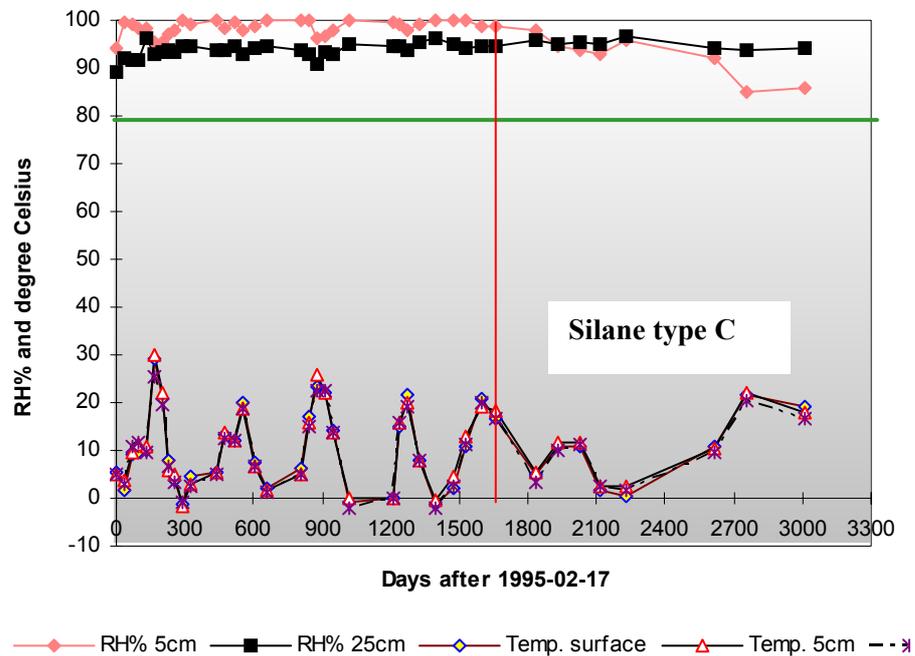
Figure 12 shows location 8 where relative humidity has been measured since 1995. After 1700 days silane type C was applied the columns, Jensen [10]. Note that the relative humidity 5 cm from the surface hereafter reduces and that relative humidity is not influenced by temperature fluctuations.

Figure 12: measurement of relative humidity and temperature at location 8. After 1700 days silane type C was applied the concrete (vertical line)

Measurements have shown that relative humidity in the concrete varies from 100% to 87% (before impregnation with silanes). Moreover profiles have shown that the relative humidity is significantly higher on western faces relative to eastern faces of columns. Expansion of cracks varies from 0.04 mm to 0.15 mm yearly. Expansion results suggest that the rate is reduced the last few years.

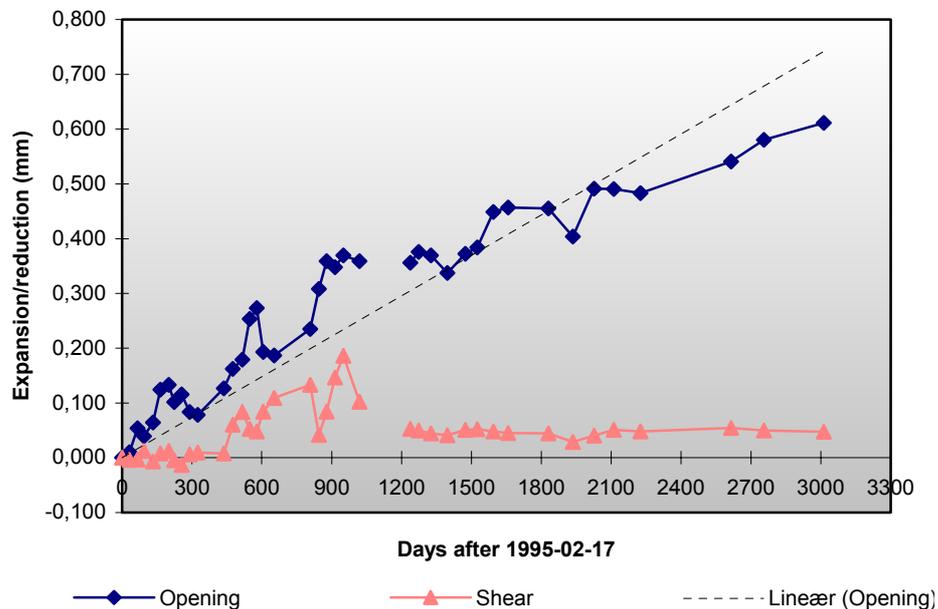
Figure 13: measurement of expansion of crack, location 3

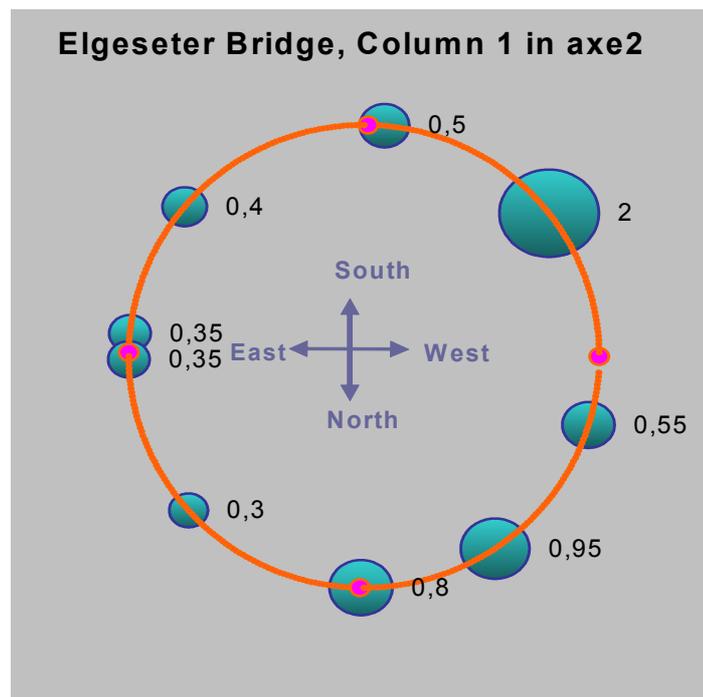
Figure 14 shows crack distribution in column 1 in axe 2 as a “bird eye view”.

Figure 14: crack distribution in column 1 in axe 2. Filled circles are individual cracks with different sizes and number is crack width in mm. Bird eye view.

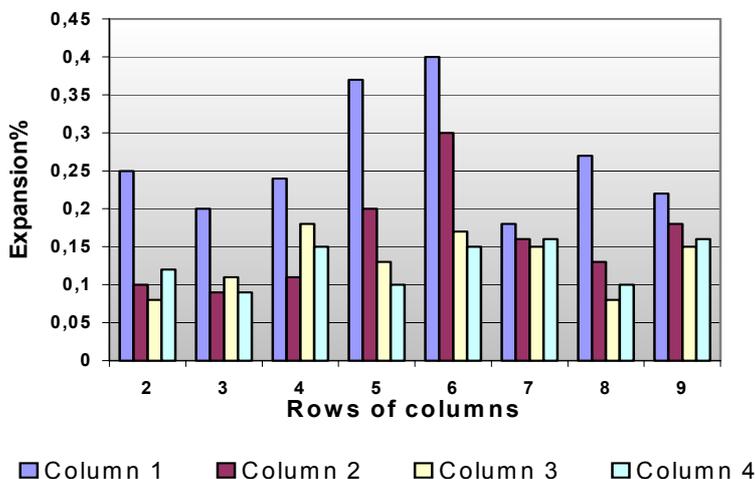
Figure 15 shows expansion from all the columns in Elgeseter bridge. Note that the highest expansions occur in columns located most westerly (column 1) and in the middle of the river.

Figure 15: distribution of expansions in columns, Elgeseter bridge

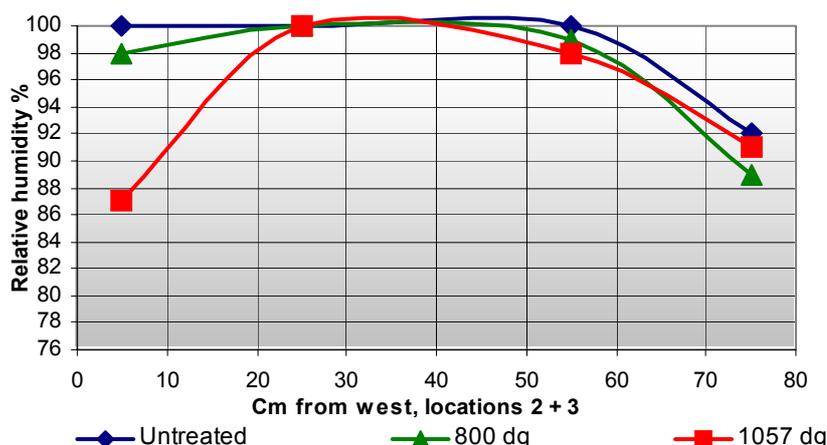
Figure 16: humidity profiles through column 1 axe 2 about 1.5 m over ground level. Measurement before impregnation (untreated), 800 days and 1057 days respectively after silane A was applied.

In all silane impregnated columns relative humidity has been reduced significant 5 cm from the surface. In the “center” of the column impregnated with silane type C (55 cm from Western face) relative humidity has been slightly reduced. Only time will confirm if the relative humidity also reduces in the middle of the columns.

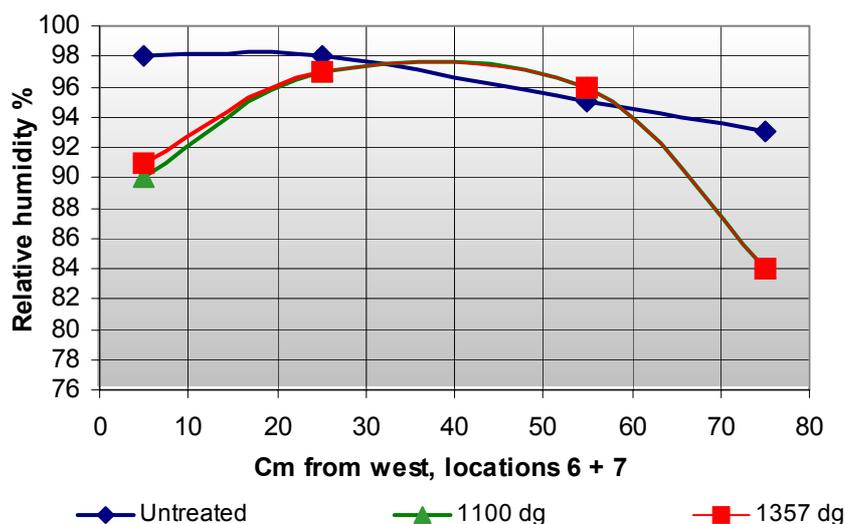
Figure 17: humidity profiles through column 1 axe 9 about 1.5 m over ground level measurements before impregnation (untreated), 1100 days and 1357 days respectively after silane B was applied.

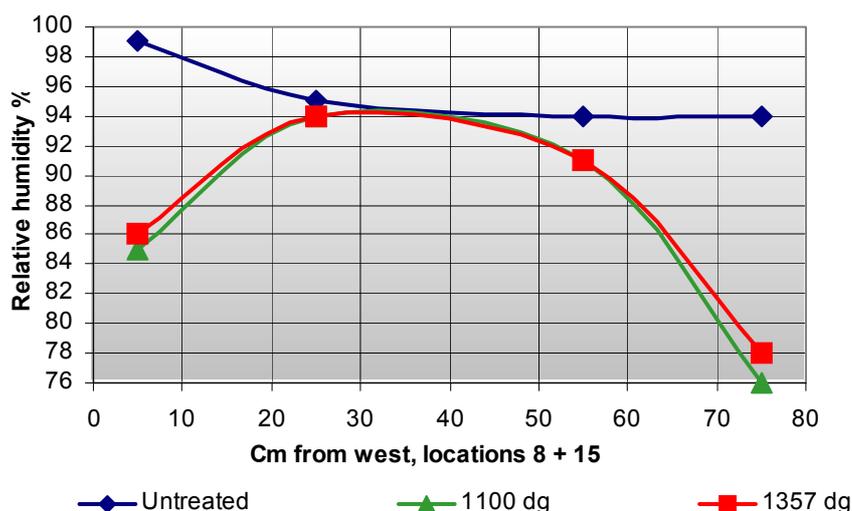
Figure 18: humidity profiles through column 3 axe 9 about 1.5 m over ground level. Measurement before impregnation (untreated), 1100 days and 1357 days respectively after silane C was applied.

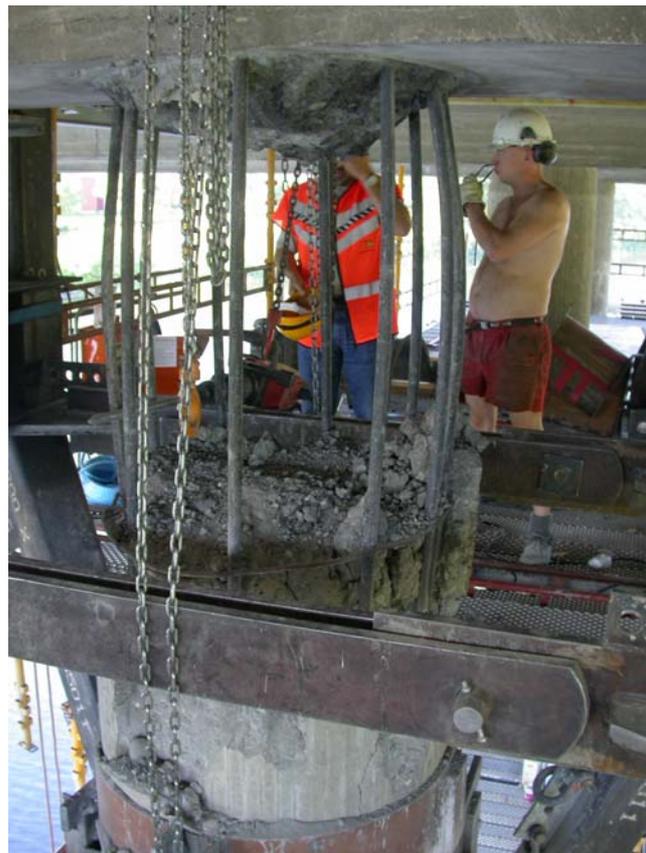
Figure 19 shows the upper part of column 3 in axe 7 where the concrete has been removed. Note that reinforcement is bent due to impact from the explosion, Jensen [14].

Figure 19: upper part of column 3 in axe 7 where the concrete has been removed.

In 2003 the Road Directorate rehabilitated all the northern columns in axe 7, 8 and 9 on Elgeseter bridge. The author has not been involved in this work or the decision behind it. Therefore, the rehabilitation work only is briefly described in the following. The major repair work was to move columns back to a vertical position. A special steel construction was made to support the beam before demolishing the upper 1 meter of the column by “micro blasting”, a Danish technique. Hereafter the reinforcement was cut and the column moved back to vertical position. Reinforcement was then welded to the beam and the upper part of the column remolded with concrete.
