ELGESETER BRIDGE IN TRONDHEIM DAMAGED BY ALKALI SILICA REACTION: MICROSCOPY, EXPANSION AND RELATIVE HUMIDITY MEASUREMENTS, TREATMENT WITH MONO SILANES AND REPAIR

Viggo Jensen, *Norwegian Concrete and Aggregate Laboratory Ltd, 7018 Trondheim, Norway*; viggo.jensen@nbtl.no

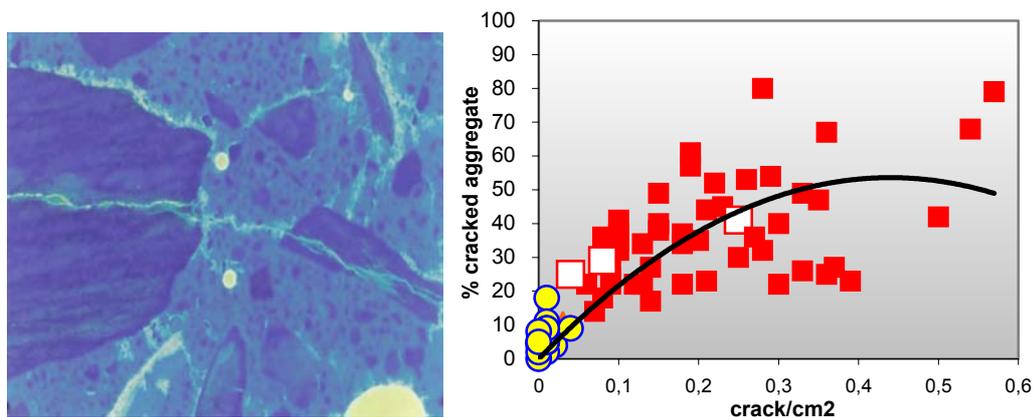
Micro structural analysis documented the occurrence of deleterious ASR caused by different rock types such as sandstone, greywacke, mylonite, phyllite and fine grained gneiss. A relationship between cracked reacted aggregates and cracks in the cement paste in cores as well as maximum cracks in structures is suggested, Jensen [1].

Figure 1: cracks in aggregates and cement paste in UV-light (left). Right figure is % cracked aggregates and cracks in cement paste from 83 cores in S. Norway with ASR (filled squares) and without ASR (circles). Results from Elgeseter bridge are shown as large empty squares.

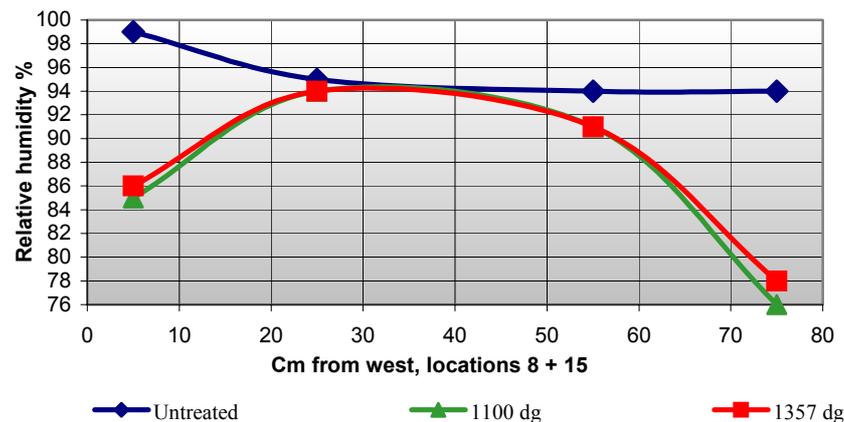
In order to measure the effect of mono silane impregnation on ASR (indirectly the relative humidity and expansion of crack) three different types of silanes were applied on 3 whole columns in 1999 and 2000 [2]. Results suggest that impregnation with mono silane reduces the concrete’s relative humidity 5 cm from the surface even when the columns are massive and ASR occurs in an advanced stage. Moreover, mono silane with a creamy consistency reduces the relative humidity to less than 80% 5 cm from the surface and should theoretically have “stopped” the ASR. Measurements of crack widths have also been carried out but the results are difficult to interpret.

Figure 2: humidity profiles through column before impregnation (untreated), 1100 days and 1257 days respectively after silane C was applied.
