IN-SITU MEASUREMENT OF RELATIVE HUMIDITY AND EXPANSION OF CRACKS IN STRUCTURES DAMAGED BY AAR

Viggo Jensen
Norwegian Research Council (NFR),
SINTEF Civil and Environmental Engineering, 7465 Trondheim, Norway

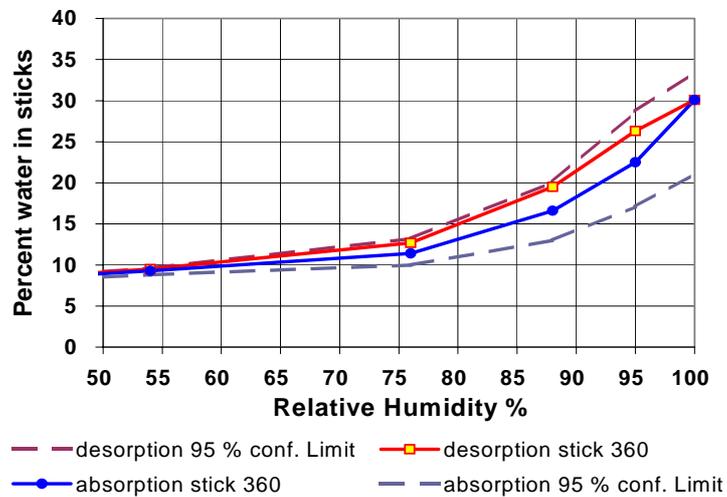
example of the adsorption and desorption curves for one wooden stick (no.360). In the figure the 95% confidence limits of 112 wooden sticks are shown with broken lines (calculated as the average of the adsorption values of 112 sticks - 2 standard deviation, respectively the desorption values + 2 standard deviation). It is easy to see that the precision of measurements is improved by use of individual calibration curves rather than by one standardized curve as used in UK and Denmark. Here an “average” adsorption curve normally has been used. The difference between relative humidity from the desorption curve and the adsorption curve can be used as measure for the uncertainty of the measurement. Note also that the inclinations of curves are higher with higher relative humidity which means the uncertainty is reduced with higher relative humidities. Note that when relative humidity > 70% the precision is about +/- 6% for the 95% confidence interval and about +/- 3% by use of individual curves (stick no. 360).

Fig. 1: Calibration curves for wooden stick no.360. In the figure the 95% confidence limits from 112 wooden stick is shown with broken line

Preparation and calibration of sticks -- The wooden sticks of the type Ramin used in the Norwegian projects have a diameter of 12 mm and are 45 mm long. Before calibration the sticks are impregnated with an Oxide impregnation liquid to prevent the wood to rotten. Correlation between water percent measured by the apparatus and relative humidity has to be done by a calibration curve made under standardized laboratory conditions (20 °C). Salt chambers with different salt solutions in equilibrium with relative humidities of 33%, 54%, 76%, 88%, 95% and 100% (pure water) are prepared. The wooden stick has to be in each salt chamber at least 3 weeks until equilibrium has been established. For each wooden stick is made an adsorption curve and a desorption curve. A calibration curve can be calculated as the average between the adsorption and desorption values. Experience has shown that calibration curves varies between the wooden stick, sometimes significantly. It has to be remembered that the 100% relative humidity value is the fiber solubility point of the wood. Higher water percent can be measured in case the wooden stick is wet (e.g. caused by condensation of water from the air) but the relative humidity is still 100%. Fig.1 shows an

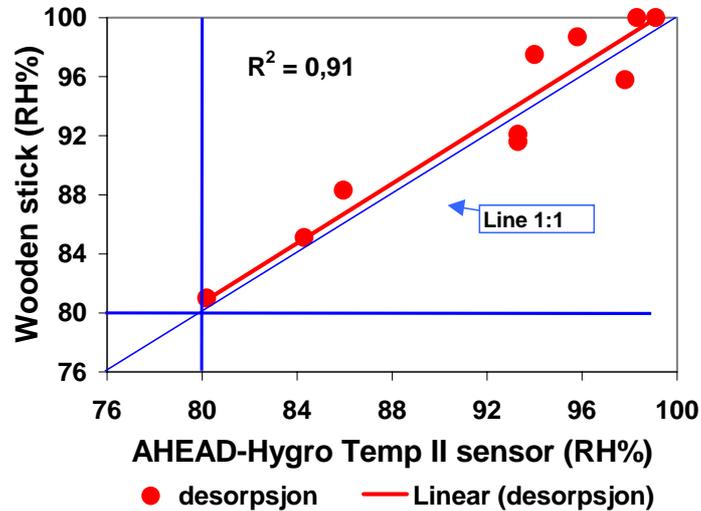
Fig. 2: Correlation between wooden stick with use of the desorption curve and AHEAD hygrotemp II sensors.

Wooden sticks mounted in Elgeseter bridge, Trondheim and frequently measured during a period on 3 years, were sealed in tight plastic bags, and taken in to the laboratory. After laboratory temperature was reached (20 °C) the WS measurements were carried out. The sticks were then put into small tight plastic containers for measurements with the AHEAD hygrotemp II probes. The relative humidity was measured when equilibrium between the wooden stick and air was established. Fig. 2 shows the correlation between the WS – method with use of the desorption curve and AHEAD hygrotemp sensors. Note the acceptable correlation between the two methods. Similar good, but slightly lesser correlation, can be shown by use of adsorption curves.

Relative humidity measurements by wooden sticks are very stable over time and lies in the interval 80% to 100% in structures with AAR, as expected. Comparison test between wooden sticks used for 3 years in a bridge structure and a commercial electrical humidity sensor system (AHEAD hygrotamp II) shows excellent correlation. By use of individual calibration curves valid only for one stick the precision in the interval 70% to 95% relative humidity can be better than +/- 3 %. It can be shown that surfaces exposed to periodically rain obtain higher humidity than leeward surfaces. The existences of humidity profiles in bridge columns and beams/columns in an office building have been demonstrated. For piers in the dam structure no significant difference in humidity occur between 5 cm and 40 cm inside the concrete. This even one of the humidity locations is located inside a house on top of a pier (no rainwater). Preliminary results of the coating systems suggest that all the systems reduce the relative humidity over time, 3 cm from the outer surface. However, more measurements and time is necessary to confirm these results. Measurements of cracks show that cracks are “alive” and expand yearly from zero to 0,25mm.

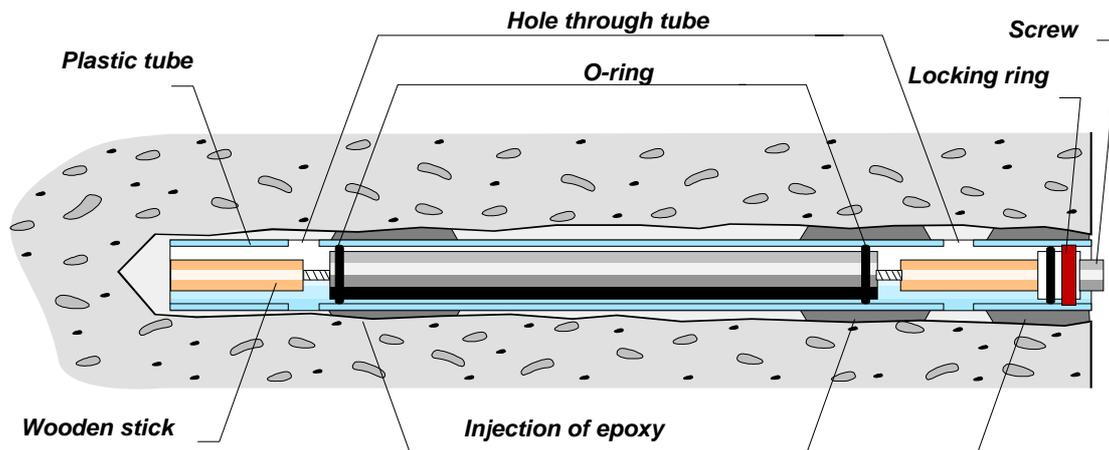
Mounting in structures -- The principle with the WS – method is humidity equilibrium between the wooden stick and the concrete. It is therefore very important that the wooden stick is not in contact with atmospheric air. In the Norwegian projects two wooden sticks (humidity profile) is mounted in a special fabricated plastic tube as shown in fig. 3.

Fig. 3: Plastic tube mounted with 2 wooden sticks. Note that the contact between concrete and plastic tube has been injected with epoxy sealers. Diameter of the tube is 20 mm.

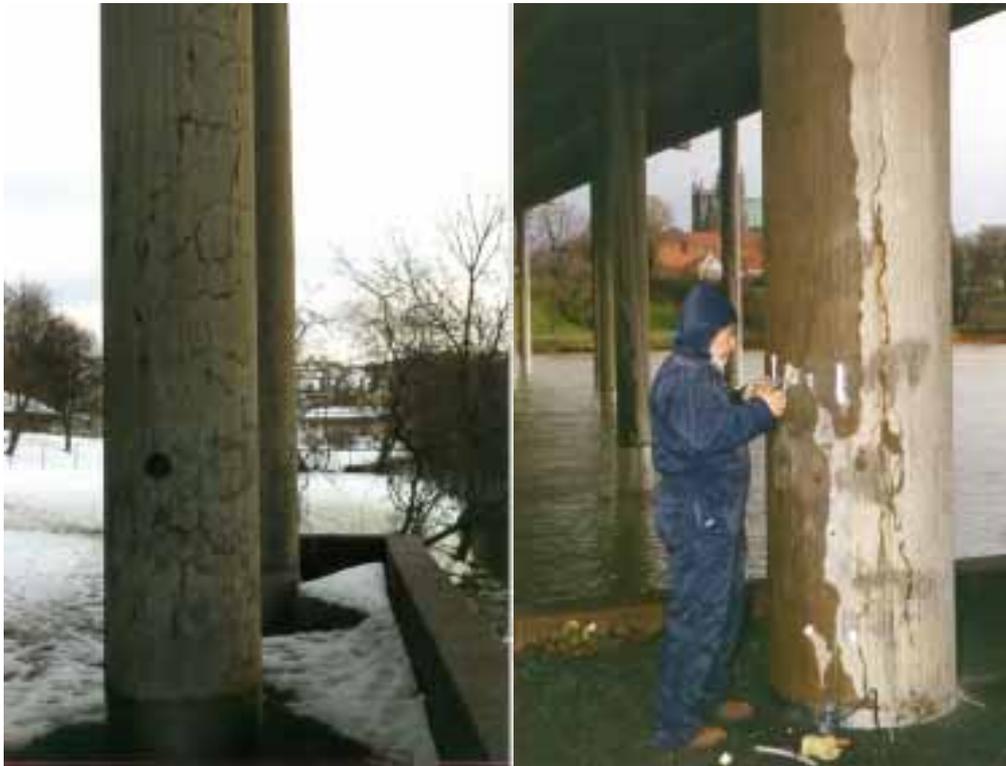
Fig.4: Map cracking and vertical cracks in columns of Elgeseter bridge. Note that the column (right photo) is wet of rainwater on western face (near the man) and dry on eastern face.

Elgeseter bridge, Trondheim – The bridge was build in 1949-1951 as a continuous 200 m long reinforced concrete beam bridge supported by 8 rows each with 4 columns with diameter of 80 cm. AAR was diagnosed in 1990 caused by the rock types mylonite, graywacke and argellite. In-situ measurements were established February 1995. In columns several verticals cracks up to 2-mm width can be followed from ground level to the underside of supported beams (10 meters). Some columns also contain map cracking, see fig. 4. Eighth measurement places have been mounted on columns/beam. Humidity by wooden sticks is measured 5 cm and 25 cm from surfaces as well as expansion of cracks, see fig. 9. Humidity profiles through 2 columns 1.2 m over ground level is established, too (western face of columns respectively eastern face), see fig. 6. Measurements of relative humidity have now been carried out for 4 years. Values are very stable with average relative humidity from 99-93 % on western faces, 5 cm and 25 cm inside the concrete and 89-87 % RH on eastern faces 5 cm from the surface.

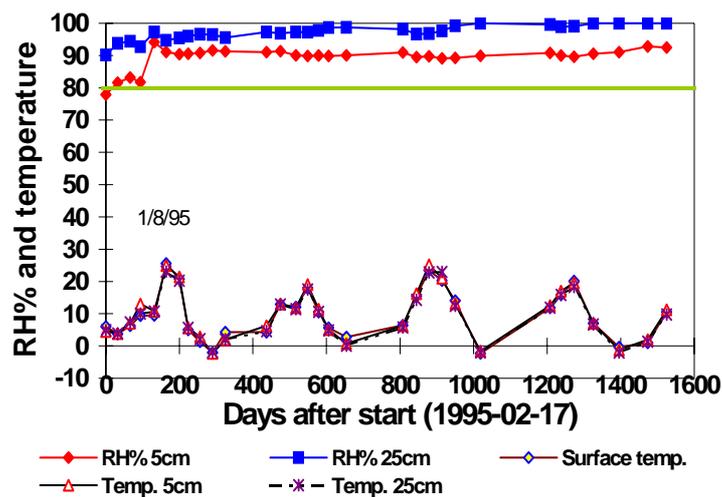
Fig. 5: Relative humidity and temperature (°C) during 4 years.

Figure 5 shows relative humidity and temperature over a 4 years period in location no. 3. Note that relative humidity is very stable over time with a slight tendency of increase

25-cm inside the concrete. In the beginning it takes some time before the wooden sticks are in equilibrium with the concrete. This because the stick was dry when inserted in the concrete. Normally it takes about 1 month before equilibrium is established because sticks now are "wetted" before inserted in the concrete. Note that temperature and yearly temperature fluctuation do not influence the relative humidity. Fig 6 shows humidity profiles through 2 columns. The profile starts from western faces, which frequently are exposed for rain. Values are average relative humidity over 4 years.

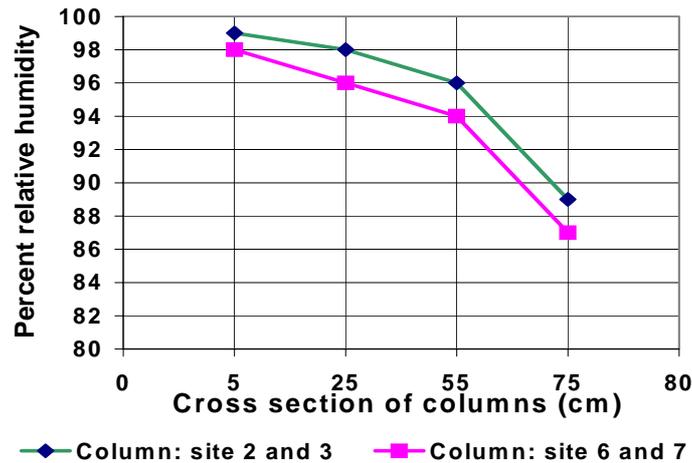
Fig. 6: Humidity profiles through 2 columns of Elgeseter Bridge starting from western faces.

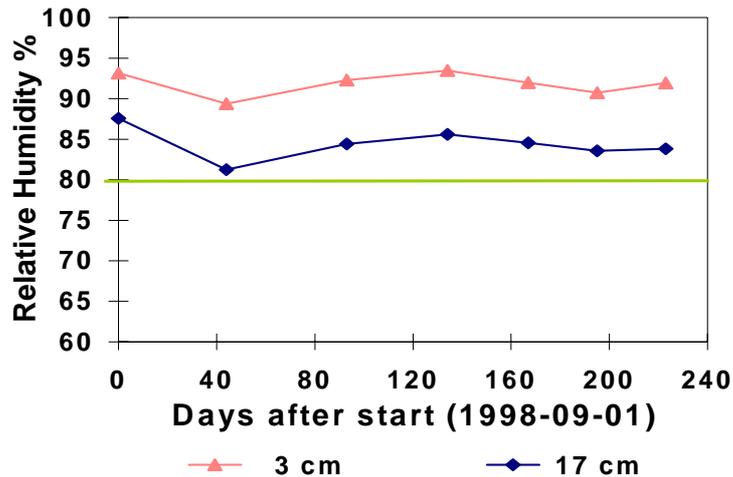
Fig. 7: Relative humidity measured 3 cm and 17 cm from outer surface in location no. 9.

systems have been applied the whole outer face of columns/beams. At writing time measurements have only been carried out 220 days and results have not been interpreted. However, preliminary results suggest that all the systems reduce the relative humidity over time, 3 cm from the outer surface.

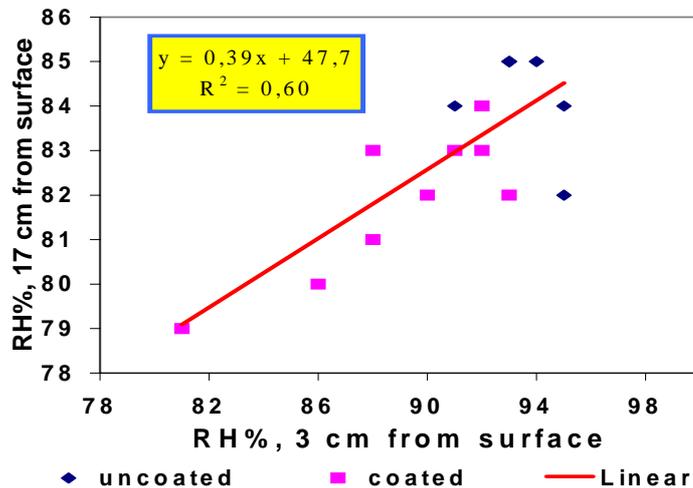
The correlation of all humidity measurements 3-cm respectively 17-cm from outer surface is shown in fig. 8. The distinct difference between coated and non-coated elements is probably accidental.

Fig. 8: Correlation of humidity measurements 3-cm respectively 17-cm from outer surface

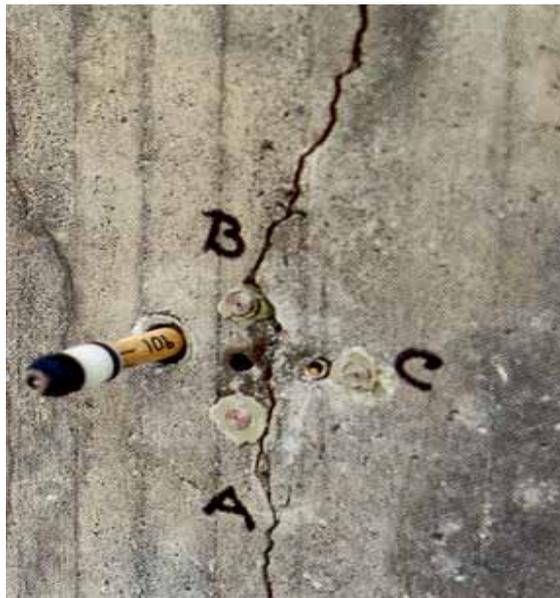
glued. Measurements along the distance A-B (always along the crack), A-C and C-B are manually measured two times by a strain gauge (Demec gauge). Calculation of expansion (opening of crack) and shear (movement parallel the crack) are carried out by a spread sheet program. All results have been corrected by use of a theoretical temperature coefficient (10^{-5} pr $^{\circ}\text{C}$). Average expansion results are calculated by regression analysis. Fig. 9 shows a location (with 3 triangular arranged rosettes) for expansion measurements along a crack, and a neighboring humidity location where the wooden stick has been pulled out of the plastic tube.

Fig. 9: Location with expansion and humidity measurements, Elgeseter bridge.

Expansion of cracks is measured by use of 3 triangular arranged rosettes (A, B, C) with an equal distances on 50 mm. Rosettes have been drilled into the surface and hereafter epoxy

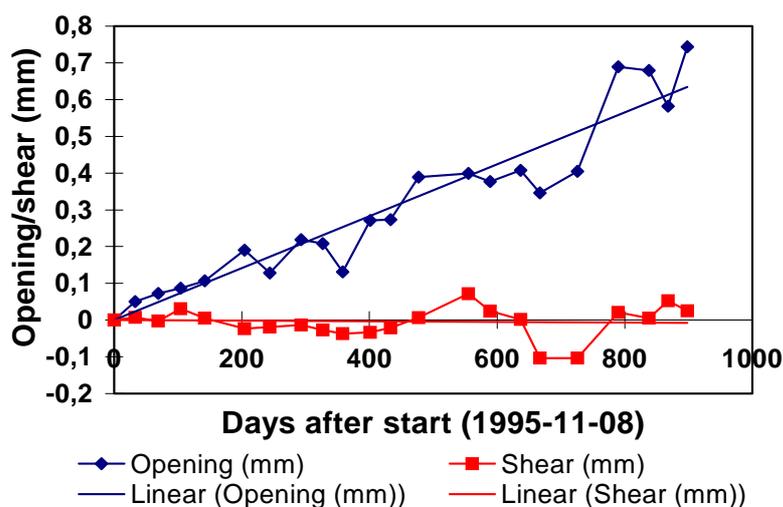
Fig. 10: Opening and shear along a crack in Dam Embretsfoss. The line is calculated from regression analysis.

The in-situ measurement system has now been in use several years in Elgeseter bridge in Trondheim and in Dam Embretsfoss, Southern Norway, both structures damaged by AAR. Up to now, measurement show that cracks are “alive” but with varying expansions. In Elgeseter bridge opening varies from 0.04mm to 0.15 mm yearly and shear from zero to 0.04 mm yearly. In Dam Embretsfoss opening varies from zero to 0.25 mm yearly and shear from zero to 0.07 mm yearly. The in-situ measurement system is now used in other Norwegian structures damaged by AAR.
