Relative Humidity Measured by Wooden Stick Method in Concrete Structures: Long Term Measurements and Reduction of Humidity by Surface Treatment.

By Viggo Jensen*

Synopsis: Measurements of relative humidity (RH) by means of wooden sticks of the species Ramin (*Gonystylus macrophyllum*) have been used in Norway since 1995. The method is especially applicable to concrete with high internal humidity as in structures damaged by Alkali Aggregate Reaction (AAR) or freezing and thawing. Results up to now show that the relative humidity is stable 5 cm from the surface and that ingress of rainwater is an important source of water in most of the outdoor exposed concrete structures. Correlation tests have shown that wooden sticks still are in good condition and reliable after 7 years continuous use. Measurements on surface treated columns and beams in two structures show that the relative humidity 5-cm from the surface decreased significantly during four years monitoring, which was not the case in untreated concrete. It is concluded that surface treatment is able to reduce the relative humidity in concrete structures exposed to rainwater.

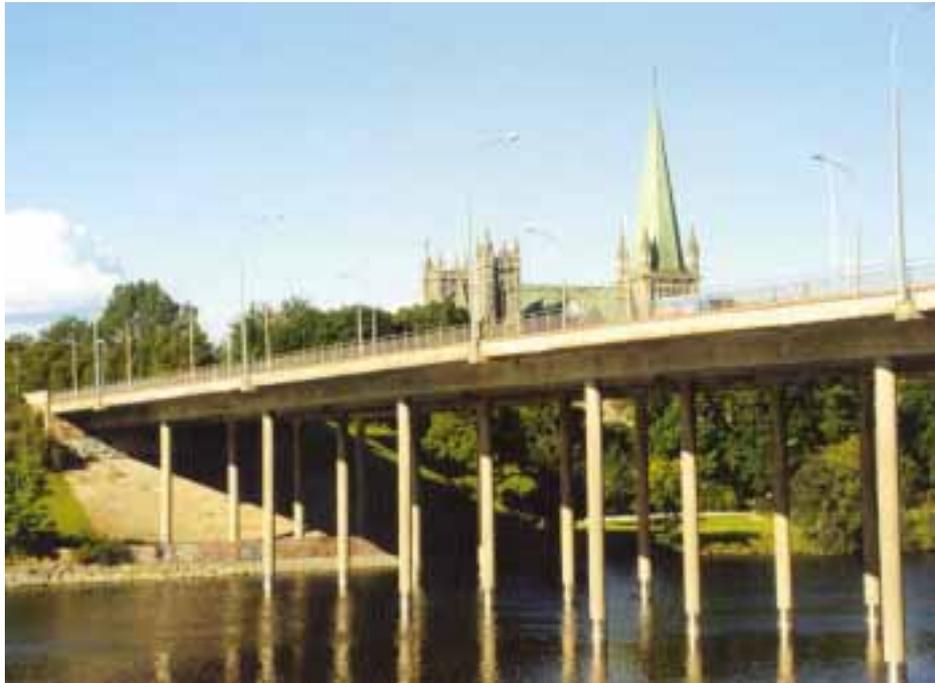
Fig 5. Northern part of Elgeseter Bridge, with the millennium old cathedral “Nidaros Dome” in the background.

Elgeseter bridge was built in 1949-1951 as a continuous 200 m long reinforced concrete bridge supported by 8 bents with 4 columns each having a diameter of 80 cm, see Fig 5. AAR was diagnosed by microstructural analysis in 1990 to be caused by the rock types mylonite, graywacke and argillite¹. In columns, several vertical cracks up to 3-mm width can be followed from ground level to the underside of the supported beams. Some columns also contain map cracking. Inspection and measurement of cracks in columns show more cracking on the western faces compared with eastern faces due to rainwater (eastern faces of columns stay dry when it rains). Measurements have also shown that columns exposed more westerly and located in the middle of the river have more cracks. Cracks are still opening and increase from 0.04 mm to 0.15 mm yearly (9).

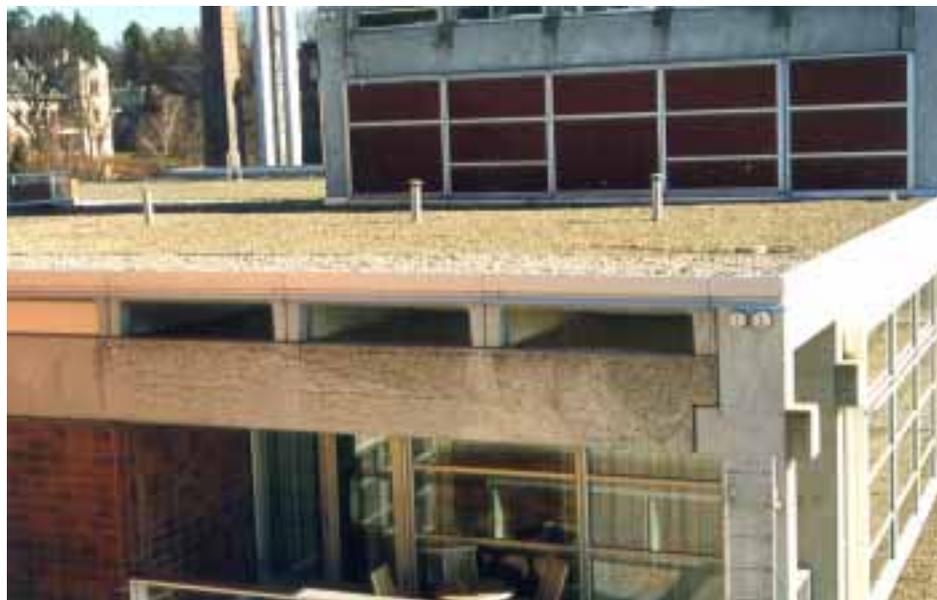
Fig. 10 The Norwegian Veritas House with prefabricated beams and columns. Note the cracked beams in the front

The Norwegian Veritas house (DNV) was built during the period 1974 - 1976 using prefabricated columns and beams. The building covers a ground area about 1400 m² with several unit buildings of 3 to 5 storey heights. Today, cracking is observed on the exposed faces of the columns and beams, mostly on the upper faces of the building, see Fig. 10. It is uncertain when cracking first appeared but employees working in the building have indicated that the intensity of cracking has increased during the past few years. In 1996, AAR was diagnosed by microstructural analysis caused by impure limestone (metamarl), sandstone and mylonite⁴. In 1998, twenty measurement locations were mounted on beams and columns on the roof of one of the buildings.
