ELGESETER BRIDGE IN TRONDHEIM DAMAGED BY ALKALI SILICA REACTION: MICROSCOPY, EXPANSION AND RELATIVE HUMIDITY MEASUREMENTS, TREATMENT WITH MONO SILANES AND REPAIR

Viggo Jensen, *Norwegian Concrete and Aggregate Laboratory Ltd, 7018 Trondheim, Norway*; viggo.jensen@nbt.no

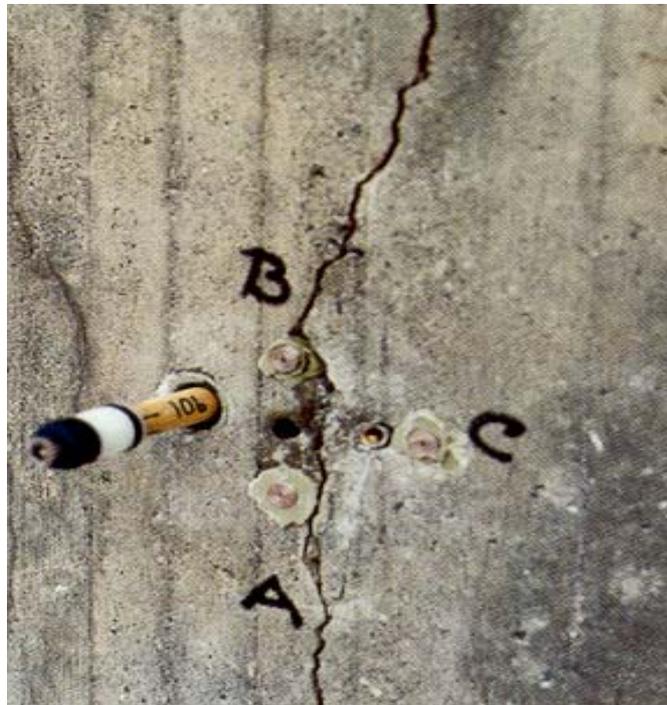
In 1995 an in-situ system for measurement of relative humidity in concrete and expansion of cracks was developed and pilot tested on Elgeseter bridge, Jensen & Haugen [5]. Eight measurement sites were mounted in one beam and 4 columns with diameter 80 cm. The concept of the system was use of inexpensive equipment and simple and systematic procedures whereby the owners of structures carried out all the measurements themselves. Relative humidity is indirectly measured by use of wooden sticks (*Gonystylus Macrophyllum*) in equilibrium with the relative humidity in the concrete, Wood [6], AEC [7], Apneseth & Hay [8], NORDTEST [9].

Fig. 11: location for expansion and humidity measurements, Elgeseter bridge.
